# 975 2½" - 10"

### **Modification Overview**

Production of the 975 (2 ½" - 10") began in 1990 and was discontinued in 2004.

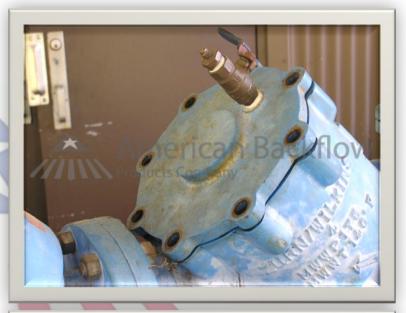
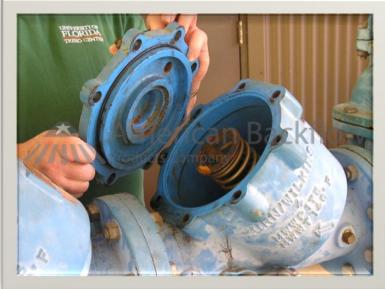
### **Check Cover Removal**

Cover is o-ring sealed.

Loosen bolts 1/2". The spring load is now released from the cover and retained by the check subassembly.

\*\* Verify spring load before removing all the bolts.

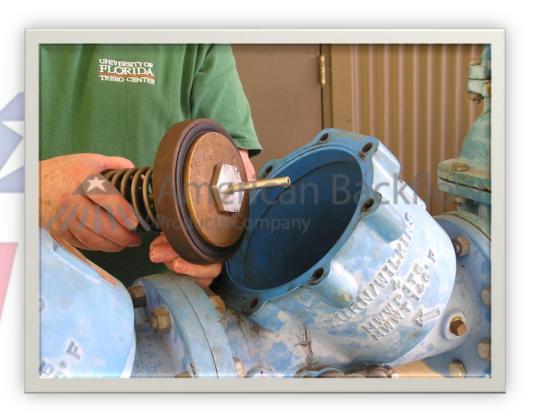
### Check Valve Removal

Center stem guided check assembly.

Disc & spring subassembly.

Slide subassembly straight out of seat and body.

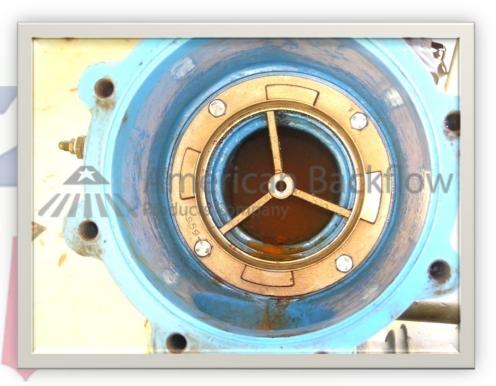
### **Check Seat Removal**

Seats are bolted into the body and o-ring sealed.

Remove the bolts and pull the seat straight out of the body.

4" - 10" - Inspect plastic guide bushing in center of seat.

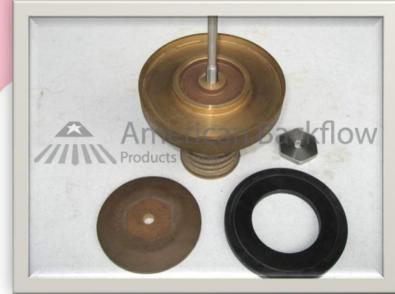
# Check Disc Replacement

Remove retaining nut and disc retainer.

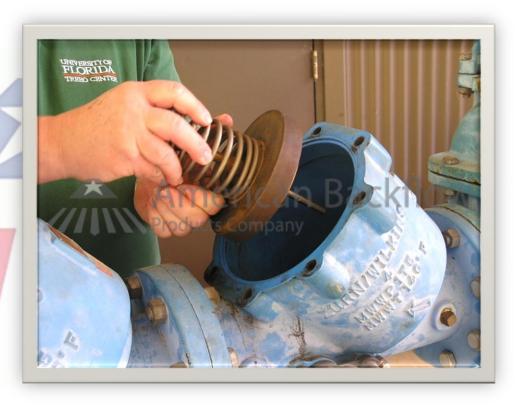
## Check Valve Reassembly Notes

Reassemble checks in reverse order.

Lubricate o-rings.

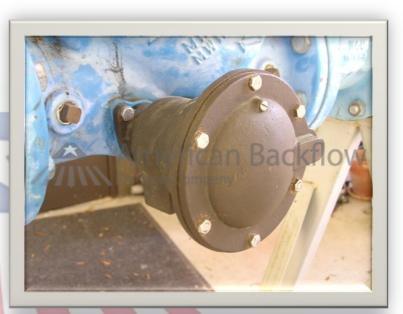
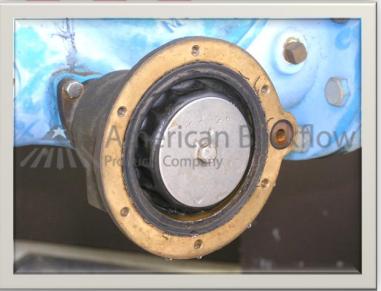
### **RV Cover Removal**

Cover is sealed by the diaphragm.

There is no spring load on cover.

Remove bolts.

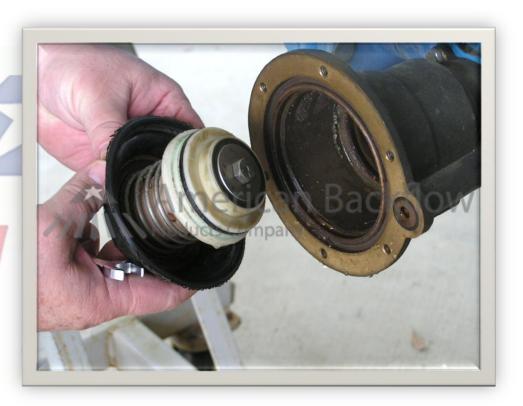
### **RV Module Removal**

Module is o-ring sealed.

Pull the module straight out of body.

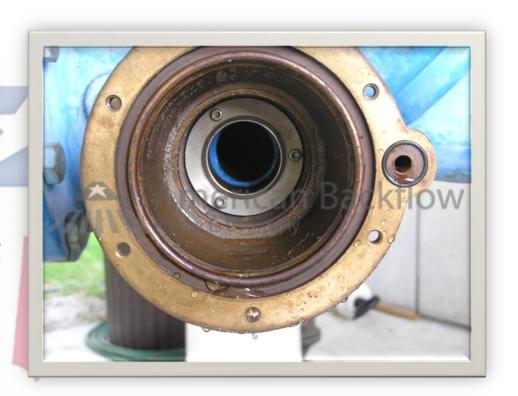
### **RV Seat Removal**

2 ½" - 6" RV seat is bolted into body and o-ring sealed.

Remove the allen screws and pull seat straight out of body.

8" - 10" RV seat is threaded and o-ring sealed.

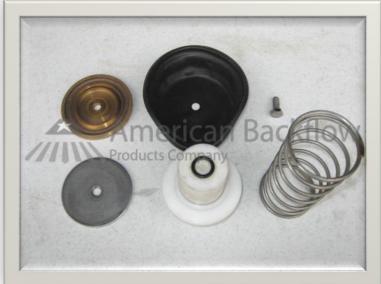
#### Disassemble RV Module

Module is spring loaded.

Holding the module firmly, remove the stem bolt.

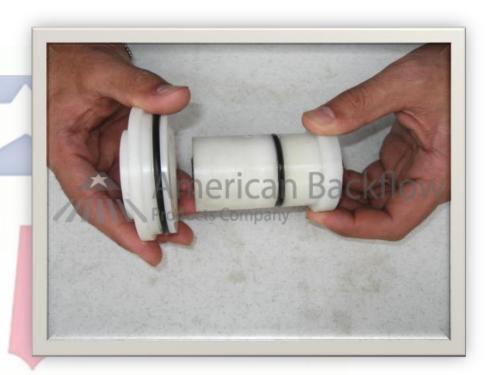
### Disassemble RV Module

Remove the guide bushing from the stem.

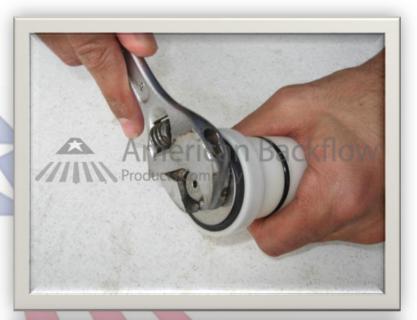
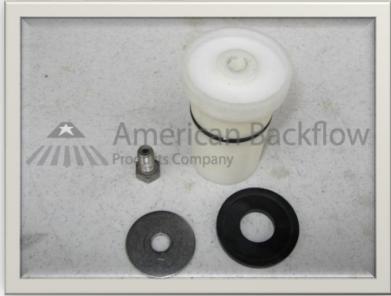
# **RV Disc Replacement**

Remove retaining bolt, disc washer, and disc.

Reassemble in reverse order.

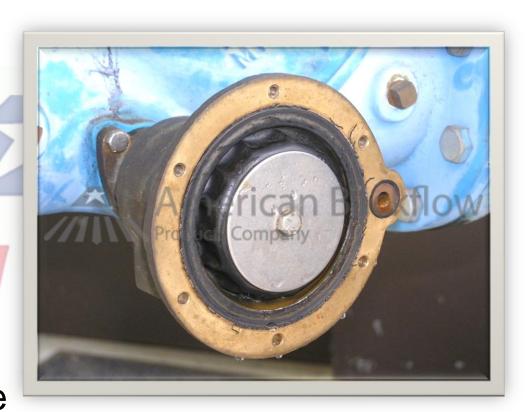
## **RV Reassembly Notes**

Bead on the edge of the diaphragm should face the disc end of the module.

Lubricate o-rings.

Push the module straight into the body.

Diaphragm bead will line up with the groove on the RV body.

Check the sensing line o-ring on the cover.
